RESTORATION PROJECT

NEWSLETTER 2

August 30, 2020

St. George Ukrainian Orthodox Church

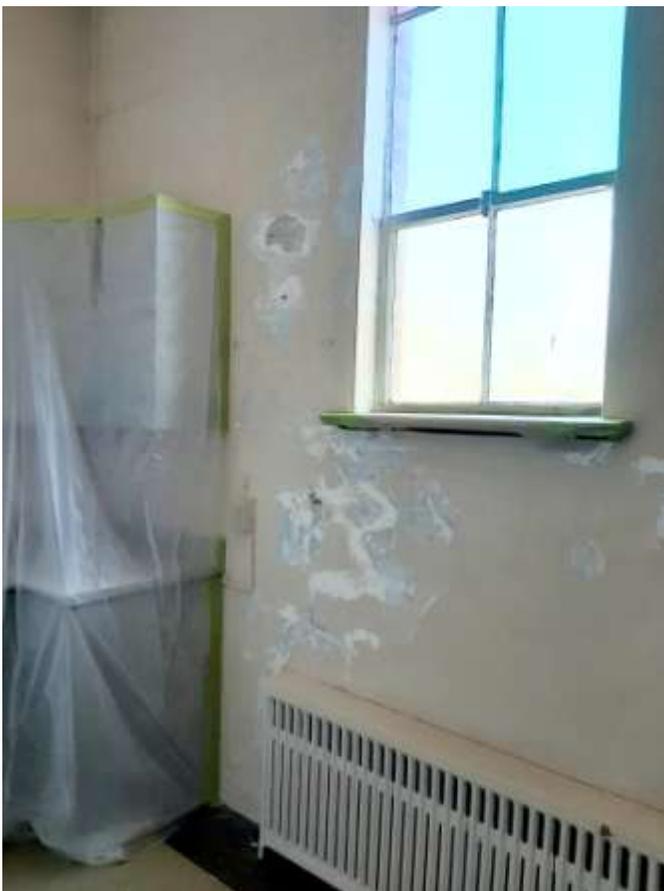
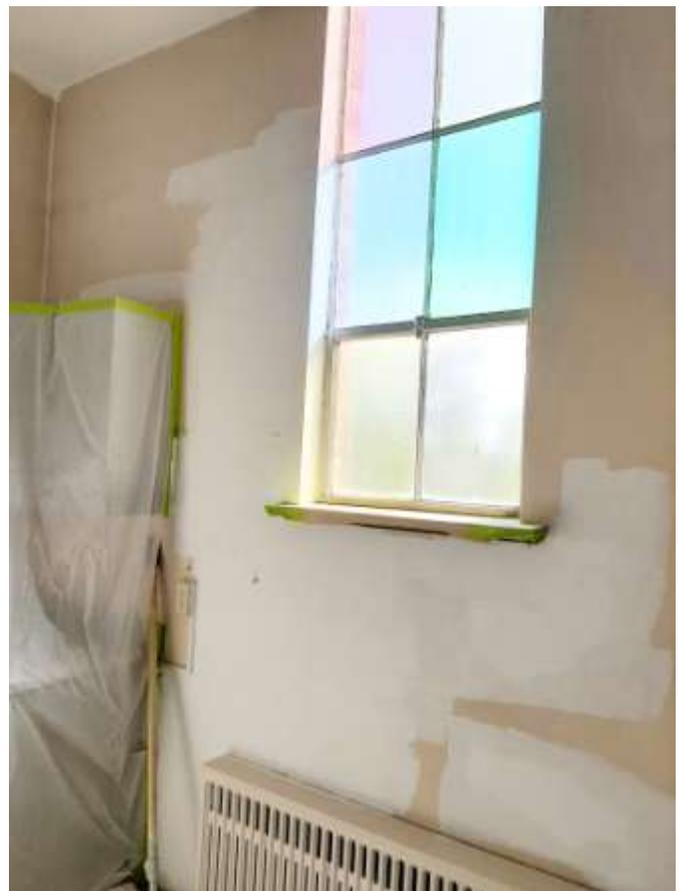
Ceiling and wall damage in the Sachristy (Pamalarka): Before and after

The first step was investigating, repairing and preparing all the damaged areas from peeling paint and water damage to accept new paint. This included scraping, patching, filling, sanding all those areas and priming with a special primer paint.

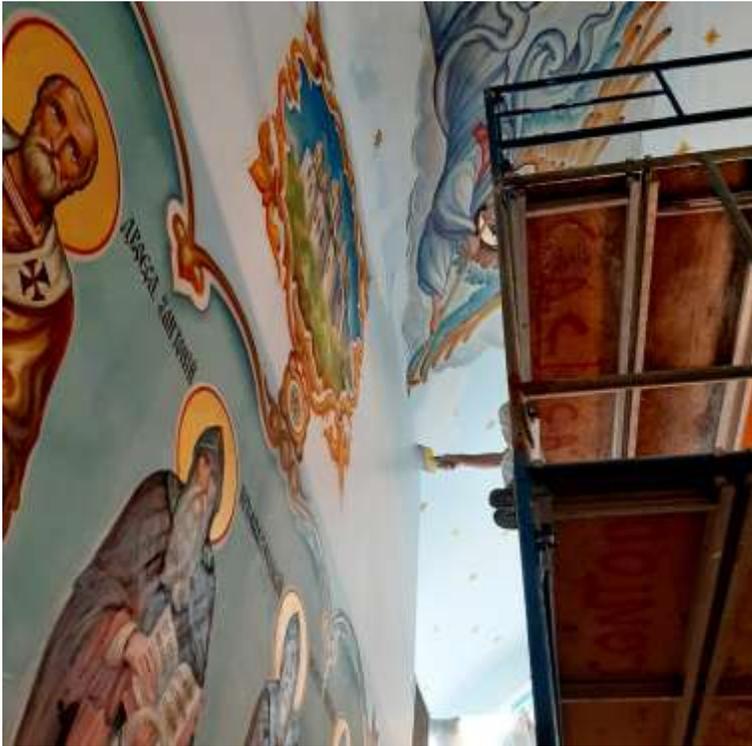
One of the painters spent more than a **week on the “cherry picker” just inside the center dome** scraping, plastering, and priming. From the floor to the ceiling in the center dome is a height of 42 feet.

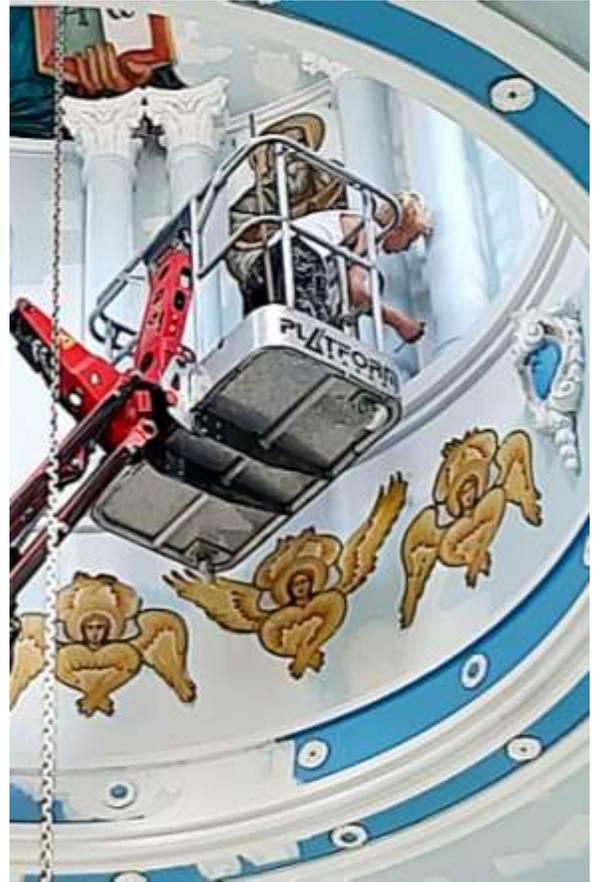
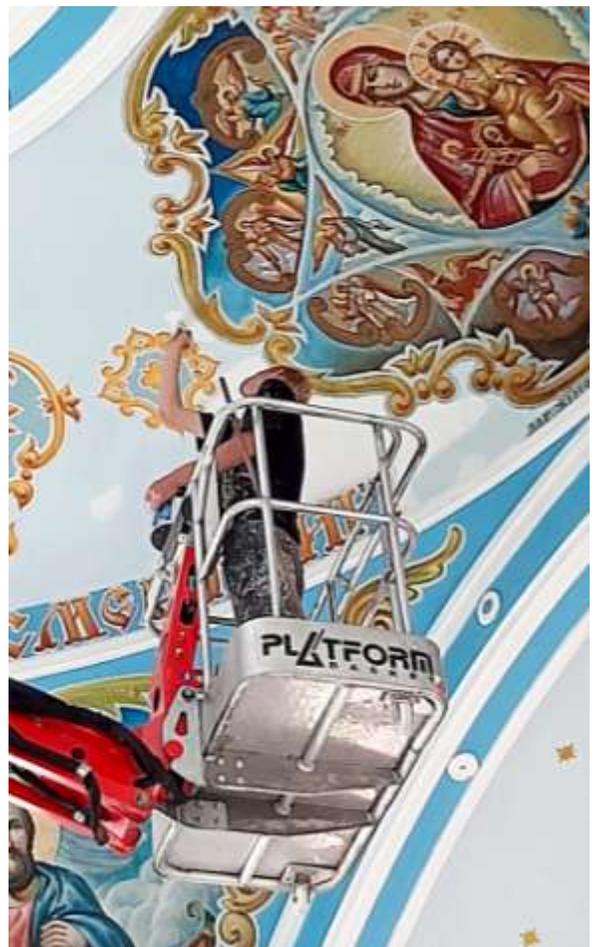
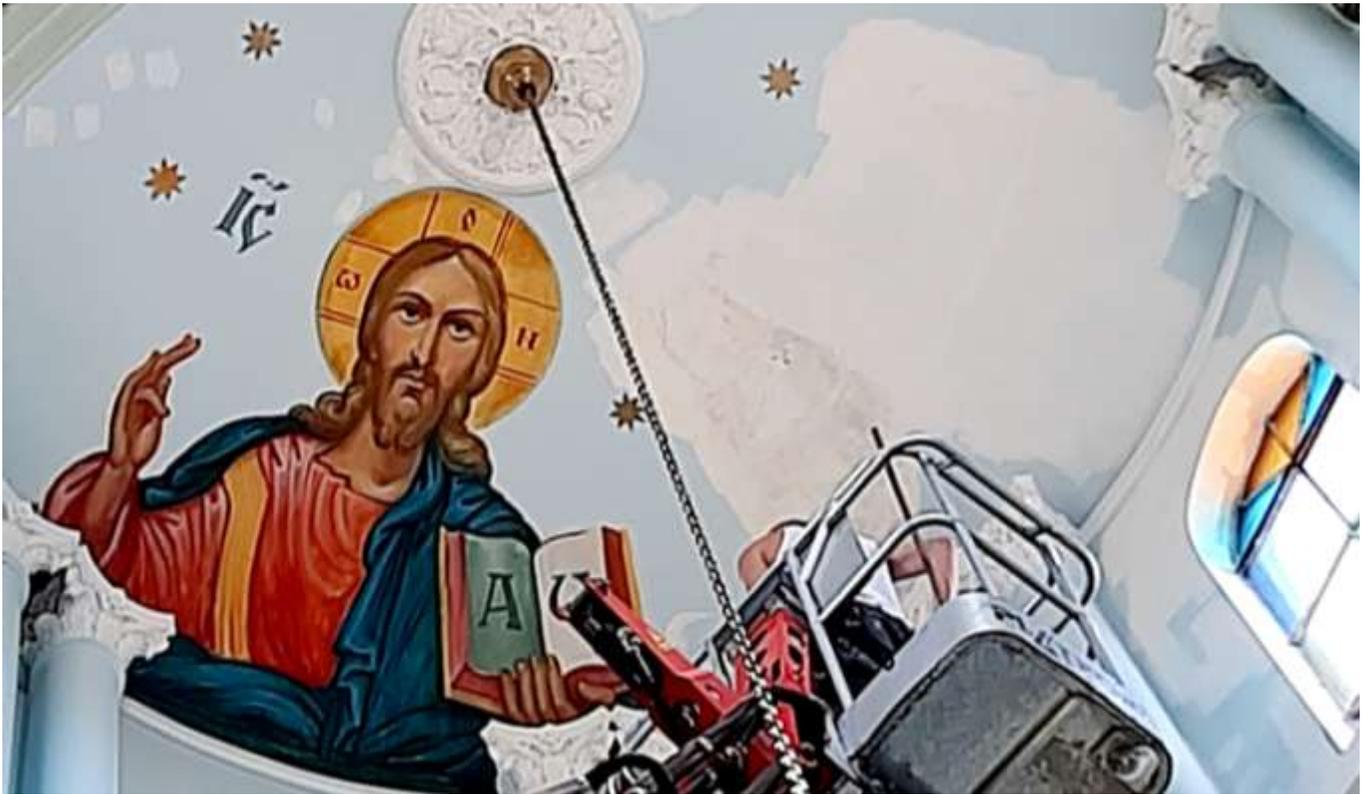
The Old Testament Saints on the walls of the center dome along with the Pantocrator (Christ) on the ceiling of the dome, had their lettering painted by hand directly onto the walls. Due to damage, that lettering is lost. Due to the safety regulations when working at heights, no local iconographer has that particular certification for working at heights to be able to reapply the lettering. The areas and remaining lettering were photographed and measured, and were reproduced electronically by Subdeacon Yakiv. From there, stencils will be made and the lettering restored by the painters themselves. Likewise all the stars will painted over and restored back in place.
